Fiber Orientation in Fiber-Reinforced Plastics and How it Affects Automotive Applications

E. M. Rowbotham
Ford Motor Co., Ltd.

Automotive Engineering Congress
Detroit, Mich.
February 25 - March 1, 1974

740264

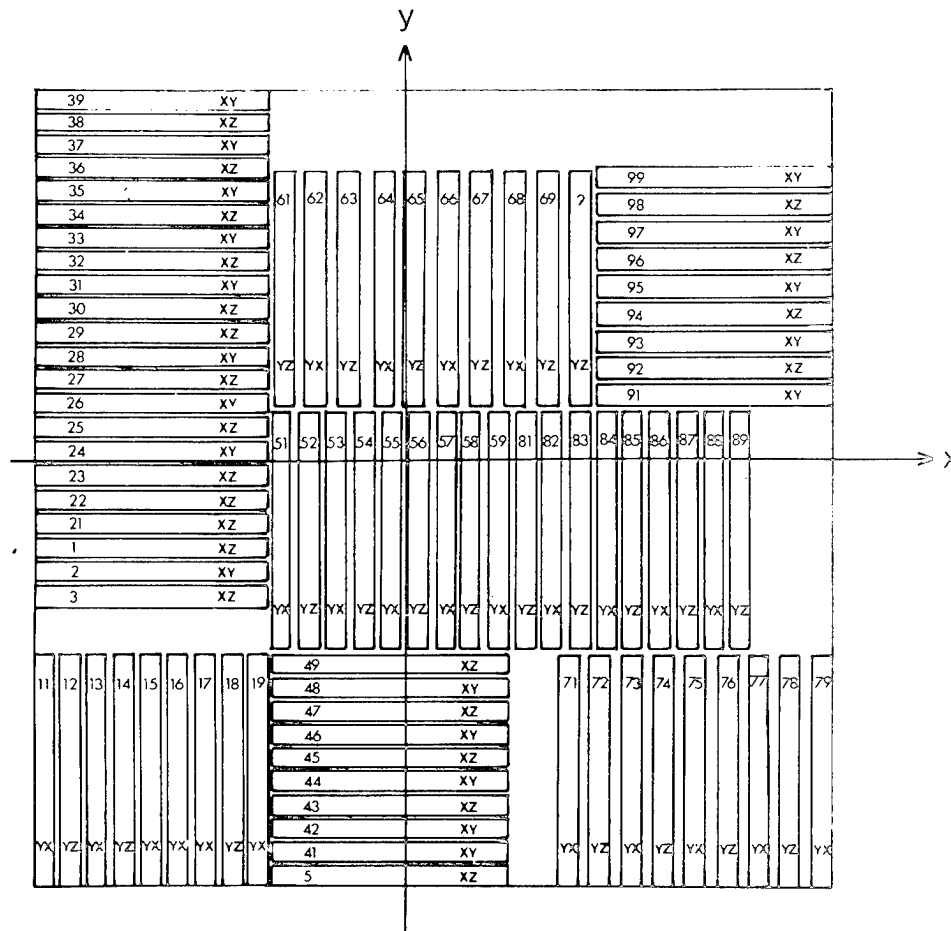
While we suspected that fiber orientation was contributing to the scatter, we did not appreciate the extent. A detailed investigation was instigated on a simple molded plaque ($305 \times 305 \times 6\text{ mm}$) of DMC (15% glass content, 6 m fiber length) to identify the principal factors involved. Eighty-seven test pieces were cut from the plaque (Fig. 1) and their cross-breaking strengths measured using a three point loading system.

Fig. 1 - Positions and orientations of specimens

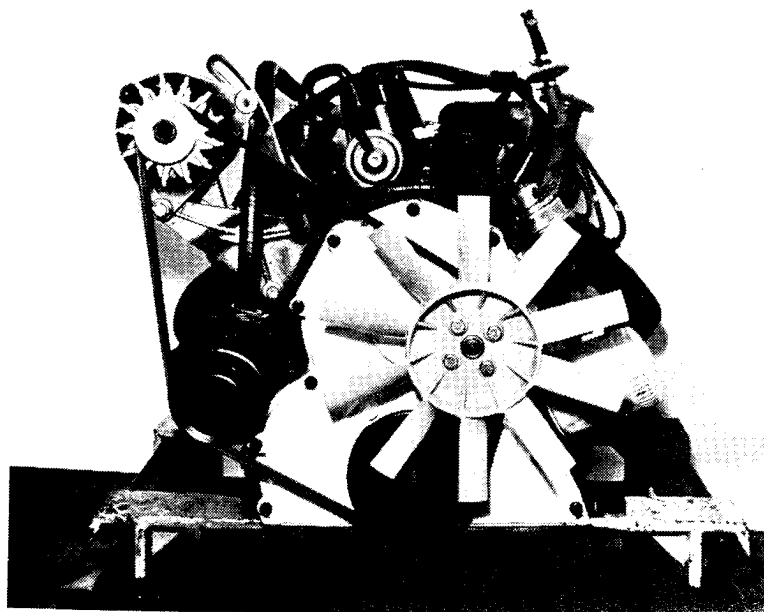
Fig. 6 - Front timing cover assembled to engine

ENGINE FRONT TIMING COVER (Fig. 6) - The molding

was made from 20% glass DMC (6 mm fiber length). The design was basically the same as its aluminum counterpart with only minor modifications such as slight thickening of the molding's outer periphery, inclusion of an extra reinforcing web at the root of the radiator fan boss, and omission of the circlip access aperture, normally included when mechanically fixing the radiator fan bearing. It is a functional component supporting the fuel pump, radiator fan, and bearing. The oil sump is bolted to the molded inserts located in bosses on the bottom sealing flange. Operationally, the component is subject to both static and dynamic stress. The fatigue stress is illustrated in Fig. 7. All tests were carried out on a 500 h engine hot test (Appendix A), inspection being made every 50 h. Tests were terminated depending upon where and to what extent cracking had occurred. Sections of the molding were cut and etched (Appendix B) to reveal the fiber orientation associated with the failure.

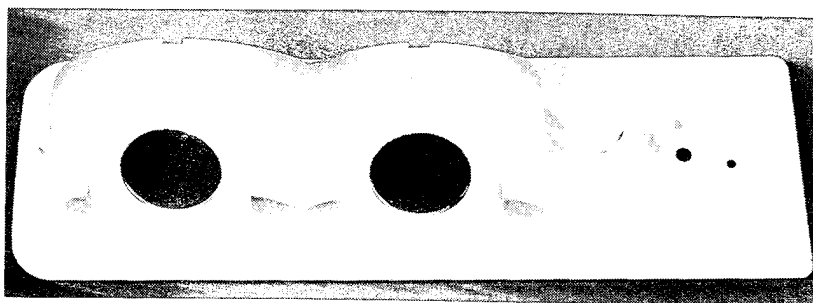
Fig. 16 - Rear tail lamp housing

Fig. 16 shows a molding of a rear lamp housing that has been injection-molded from 20% glass DMC, 6 mm fiber length. As can be seen in this molding, the sections are extremely thin; so the shear effects on the material during flow should be very high, thus producing gross fiber orientation. The etched surface of this molding (Fig. 17) shows almost complete random surface fiber orientation, apart from the slight swirl condition present around the feed sprue area. A section of this same molding with the surface skin ground off to reveal the material core shows the fiber orientation that was anticipated to occur on the surface (Fig. 18). The exact reason for this effect has not been elucidated. However, the internal forces in the flowing material must be greater than the frictional forces being experienced at the mold surface and must, therefore, become the controlling factor. Whether this is a function of the particular mold surface or the fact that the material, when injection-molded, is very close to its curing temperature and, thus, has a higher viscosity than compression-molded material, or that the material is being forced very rapidly through the mold, has not been established, but we suspect it is a combination of all these factors.
